Manhole Inspection Summary

Manhole # S49GG_031MH

Insp Date: **3/2/10 3:38 PM**

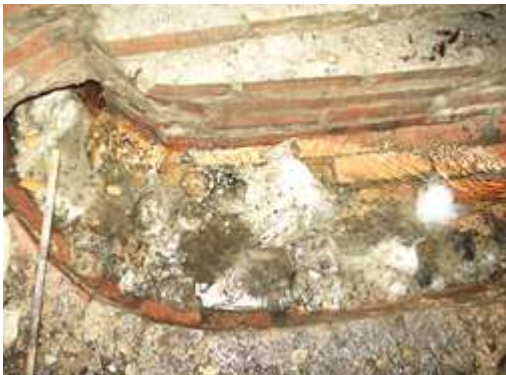
Defect 3

Condition: ☐ Sound ☐ Cracked ☐ Root Intrusion ☐ Deteriorated ☐ Leaks ☒ **Debris**

debris

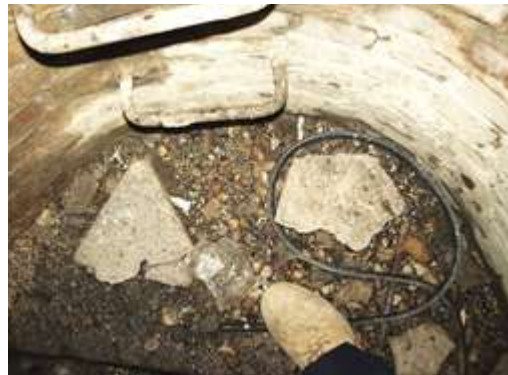
Defect 2

Condition: ☐ Sound ☐ Cracked ☐ Root Intrusion ☐ Deteriorated ☐ Leaks ☒ **Debris**

debris

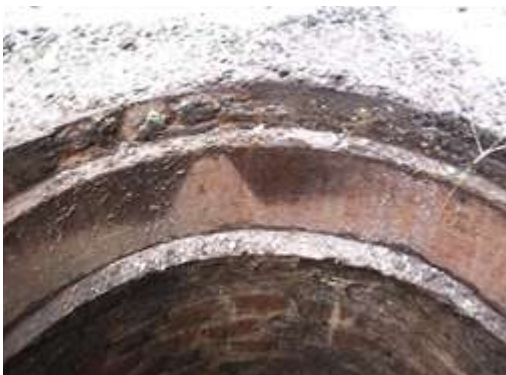
Defect 1

☒ **Leaks**

frame leaks

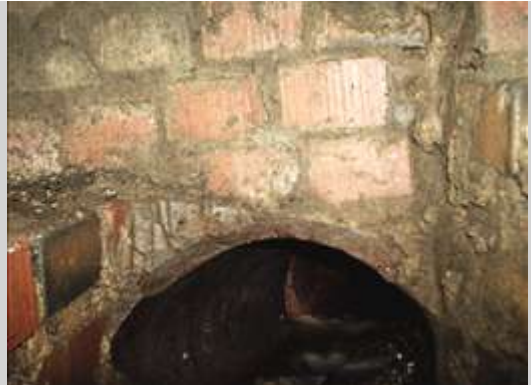
12 O'Clock Outflow

Pipe Height: **12** (in.) Rod and Bar (Angled)
Pipe Material: **Clay** ☐ Pipe Lined
Invert Depth: **8.92** (ft.) Flow Characteristics: **Slow**
Deposits: ☒ None ☐ Mud ☐ Sludge ☐ Debris ☐ Grease
Silt Depth: (in.) Deposits Extent:
Infiltration: **None** Pipe Seal Cond: **Sound**

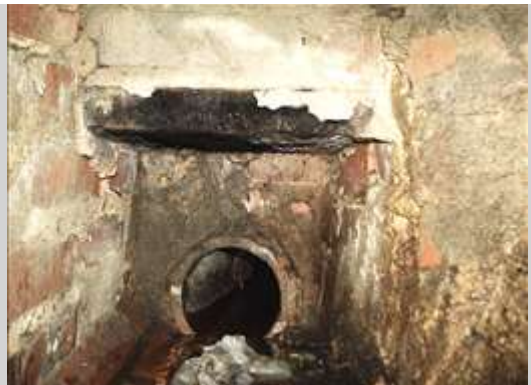
6 O'Clock Inflow

Pipe Height: **12** (in.) Rod and Bar (Angled)
Pipe Material: **Clay** ☐ Pipe Lined
Invert Depth: **8.83** (ft.) Flow Characteristics: **Slow**
Deposits: ☒ None ☐ Mud ☐ Sludge ☐ Debris ☐ Grease
Silt Depth: (in.) Deposits Extent:
Infiltration: **None** Pipe Seal Cond: **Sound**
